***FCC Debutanizer Revamp for Flexibility and
Additional Capacity***

Presented at the Distillation Symposium
2001 AIChE Spring National Meeting, Houston, Texas
April 22-26, 2001

FCC DEBUTANIZER REVAMP FOR FLEXIBILITY AND ADDITIONAL CAPACITY

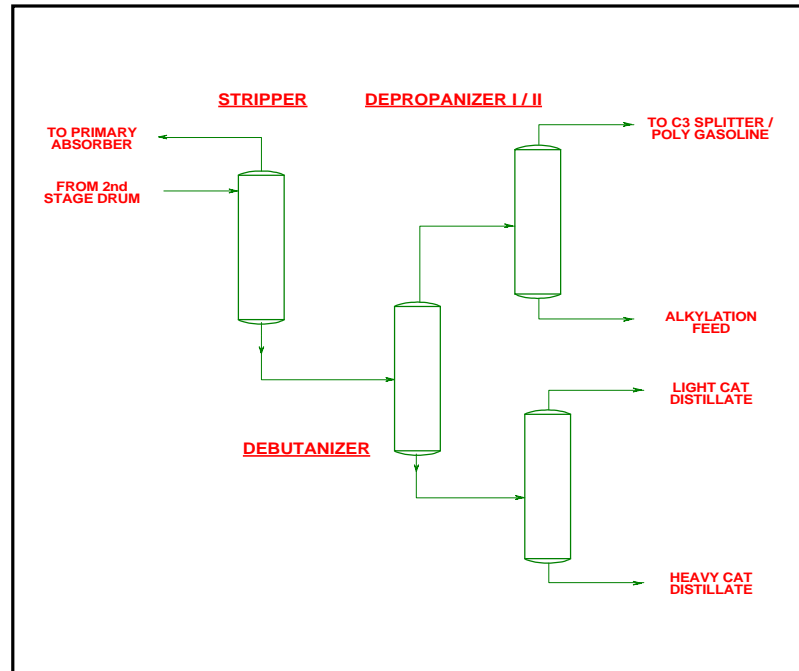
**Figure 1: FCC Liquids Recovery Unit
BP-Amoco Toledo Refinery**

The FCC gas plant for the BP-Amoco Toledo refinery is shown in the figure below.

The liquids recovery unit (LRU) is typical of most major FCC units.

The Deethanizer absorber / stripper system is operated in order to maximize C_3 recovery and C_2 rejection. The bottoms of the stripper flows to the Debutanizer where FCC gasoline is stripped to an RVP limit. The overhead of the Debutanizer is sent to the downstream Depropanizer where the C_3 's are separated from the butanes. The overhead of the Depropanizer is sent to the P/P Splitter where propylene is produced for local consumption.

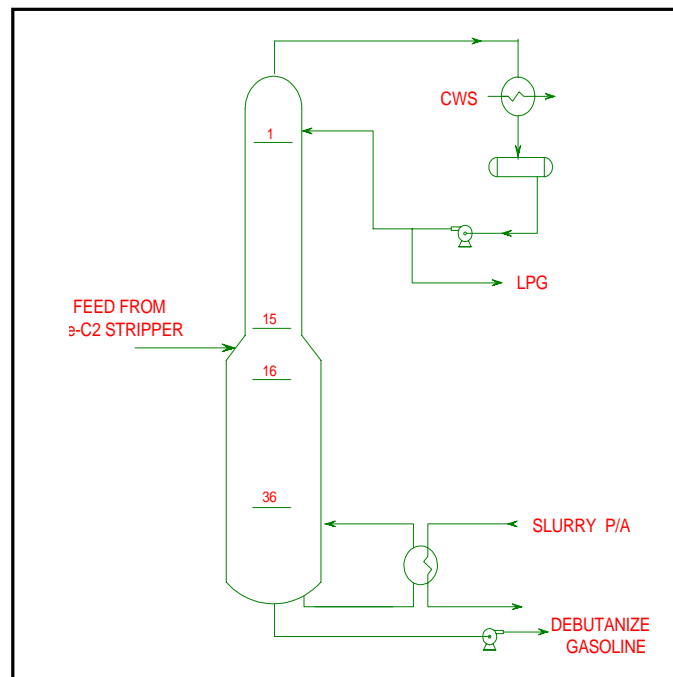
Figure #2: FCC Debutanizer PFD

The Debutanizer contains 36 trays with the feed location between Tray #15/16 from the top (see Figure #2 for a schematic of the Debutanizer).

The Debutanizer overheads is water cooled prior to entering the flooded overhead drum. The reflux is flow controlled to the tower. The overhead product is controlled via flow and pressure control to two Depropanizers. The reboiler heat is supplied via hot slurry oil and is controlled based on an RVP analyzer / tray temperature combination.

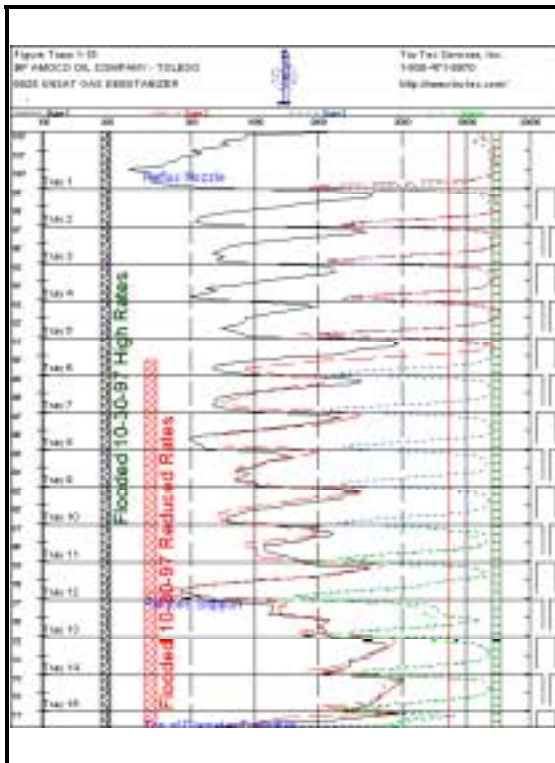
Figure #3: Rectification Section Scan of Revamp #1 @ conditions listed in Table II

Within the organization, the reasons listed above for flooding were routinely ruled out after additional scan and process data were becoming available. Shown in the figures attached are the scans that BP-Amoco executed for the stripping section and rectification section.

The tower was scanned through the active areas of the tray. The scan identifies the flooded areas of the tower. When a tray is at or above incipient flood, the scan line for the active area starts to move away from the hatched area called “clear vapor space”. This indicates froth entrainment to the tray above and signifies that liquid is not obtaining disengagement from the up-flowing vapor.

The scan identifies that both the rectification and stripping section of the tower are operating at flooded conditions (liquid height on the tray decks is high), at lower than design rates. The Revamp #1 trays were operating at a small increment higher rates than the former sieve trays.

The first question above was addressed during the scan shown in Figure #3. If the tower had seen tray damage, this would be evident in the scan. A damaged tray can show several characteristics in a scan through the active area. Most of the time with a damaged tray, the scan at the tray elevation will show up with a sharp peak that falls as quickly as it ascends. This indicates no “froth” or liquid build-up / activity on the tray. All of the trays in the scan show liquid build-up, so therefore, damage was excluded from the list of possible causes.

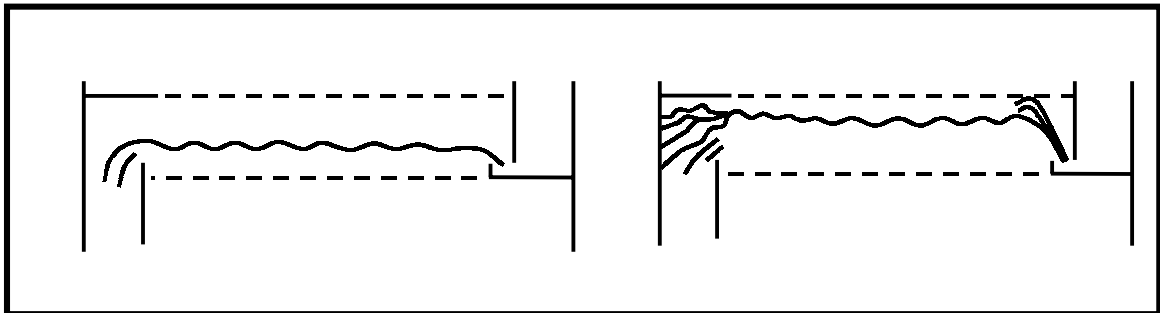
Figure x: Low vs. High Weir Loading

Several different possibilities for weir loading operation exist. Schematic of the Low Weir Loading vs. High Weir Loading is shown in the following figure.

At high weir loadings, several phenomena occur:

- Inlet “Liquid Rooster Tail” appears as described by Lockett.
- The disengagement space becomes shorter due to increased froth height on the tray.
- Liquid “jump” over outlet weir becomes high and downcomer inlet velocity is affected.
- Liquid has difficulty in entering into downcomer mouth.

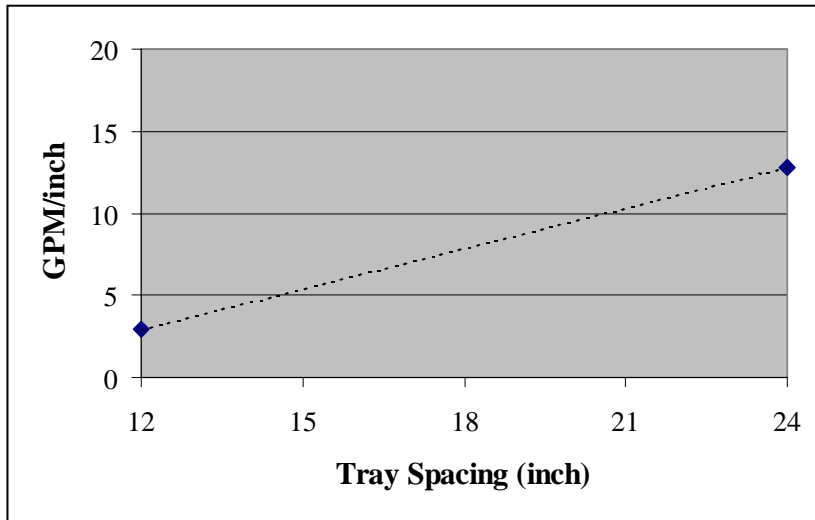
Figure 5: Maximum Weir Loading vs. Tray Spacing (Lockett, 1986)

There are many liquid loading criteria that have can be extracted from public domain materials. One of the more prominent liquid loading criteria can be found in the Lockett ⁷.

The above criteria are industry accepted guidelines. Koch-Glitsch has exceeded these high liquid guidelines by utilizing specialized tray features to limit froth height and promote liquid distribution to the active area. These applications have been made possible by testing Superfrac trays in the pilot plants at loadings up to 25 GPM/inch of weir.

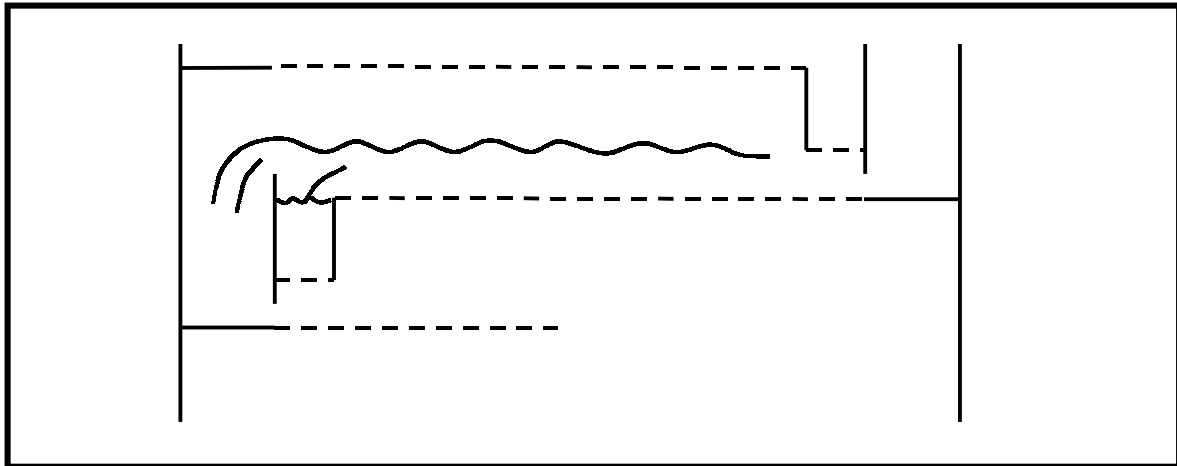
Figure 6: Superfrac Multi-Step Downcomer for High Liquid Rates

BP accepted the recommendation and contacted the available reference for input to the particular design considerations. The critical design parameter was to settle on the tray dynamics and design while operating at high liquid rates. The liquid rates for this design required several particular design modifications to the tray to handle the high liquid and the resultant liquid gradients on the tray.

Utilizing the Multi-Step Downcomer (MSD) eliminates a portion of the crest height of liquid over the weir so the resultant froth height on the tray is lower. This provides additional capacity for the tray by increasing the amount of disengagement space at a particular design capacity. Because the MSD is immediately prior to the downcomer (at the exit), the efficiency of the tray is not hampered by any reduction in liquid residence time on the tray.

For this debutanizer, this revamp required that the new trays fit up to existing downcomer bolting bars. No adaptors (Z-bars) were utilized to increase the downcomer sizing. Koch-Glitsch did not recommend changing or enlarging the size of the existing downcomers. To make fit-up in the field easier, Koch-Glitsch filled in the existing inlet sump. The inlet sump was utilized by the prior trays to decrease the downcomer aerated backup by providing more room for de-aeration in the downcomer. This feature was not utilized for the revamp design.

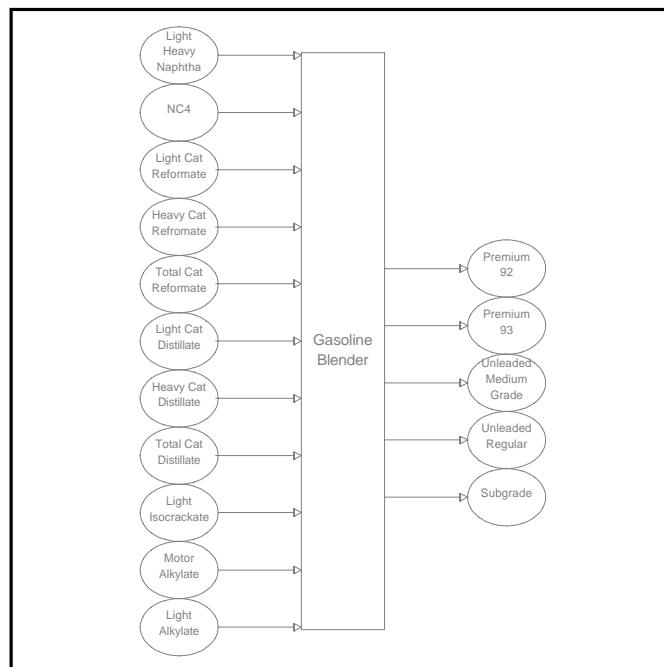
Figure #5: Refinery Gasoline Block Diagram

Shown below is the refinery gasoline pool for the Toledo refinery. The blending streams entering into the gasoline pool come from the FCC, Alkylation, Isomerization, Coker, and Crude units.

The “finished gasoline” to sales has to meet certain distillation properties for the local market, seasonal vapor pressure regulations, and sulfur limitations.

Lowering the FCC Debutanized gasoline RVP, the largest product stream to the pool, provided BP-Amoco with additional flexibility in other units. Since the FCC gasoline was the largest volume contributor to the pool, a deviation was controlled by modifying the smaller streams. After revamp #1, the tower could barely meet the 7.5 PSI RVP limitation to meet the lower RVP summer operations. At the high RVP, all other pool streams had to be processed at a lower light-ends composition. This was particularly limiting to the blending flexibility at the refinery. This took a particular toll on some of the other processing units that were already at their limitations.
